Re: Raskarity Road Dam
SEA Project 987068

Thank you for calling us to give you our opinion of the condition of the referenced dam. The following are our observations and recommendations.

SUBJECT RASKARITY RD DAM

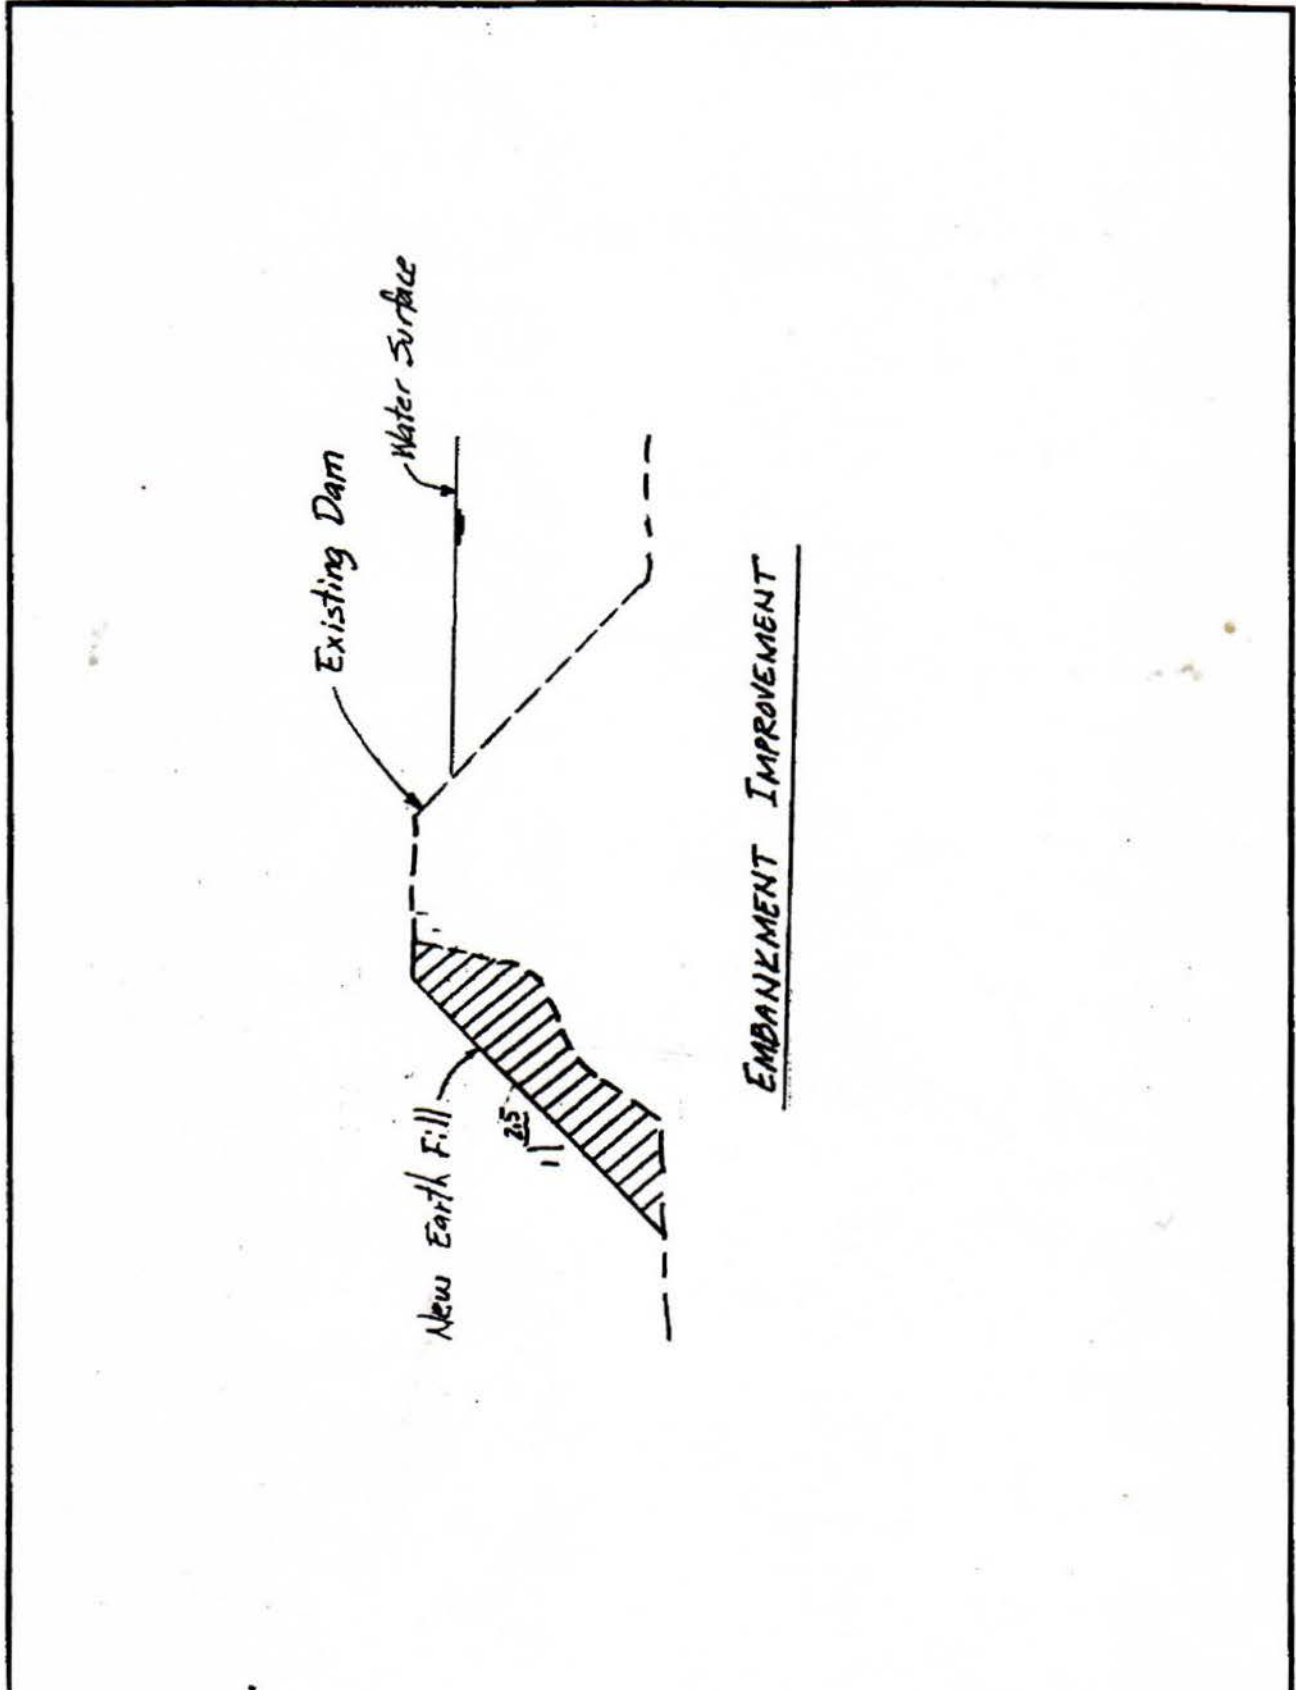
1. The downstream slope of the dam is of primary concern. There are several areas where slope failure has occurred. There are also trees growing on the back of the dam. The embankment appears to have been well compacted during construction. This is evident due to the minor seepage at the bottom of the downstream embankment. However the stability of the dam is in jeopardy due to the slope failures.

1. Stabilize the downstream slope of the embankment. This will require clearing and grubbing of the trees and vegetation from the existing slope and proposed construction area. New earthfill should be placed to stabilize the embankment. The slope of the new embankment should not be steeper than 2.5 horizontal to 1 vertical. The construction of this embankment may require extending the principal spillway pipe.
2. To minimize the muskrat population, the larger vegetation on the upstream face of the dam should be removed and the embankment maintained.
3. Maintain the vegetation at the entrance to the emergency spillway.
4. Provide a trashrack for the principal spillway riser and maintain it by removing any build-up trash around the riser.
5. Monitor the erosion downstream of the emergency spillway. This area may need to be stabilized if the head cut continues.
